Manhole Inspection Summary

Manhole # S350__029MH

Insp Date: **1/24/08 8:31 AM**

Location Address: **s charles st**

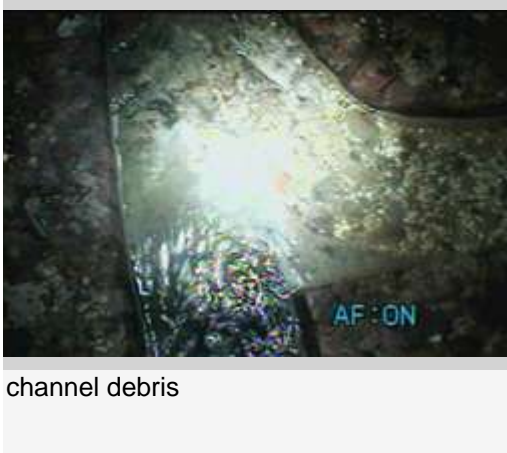
Defect 2

Condition: ☐ Sound ☐ Cracked ☐ Root Intrusion ☐ Deteriorated ☐ Leaks ☒ **Debris**

channel debris

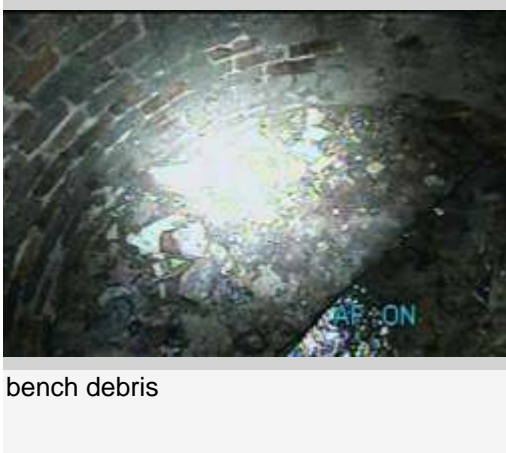
Defect 1

Condition: ☐ Sound ☐ Cracked ☐ Root Intrusion ☐ Deteriorated ☐ Leaks ☒ **Debris**

bench debris

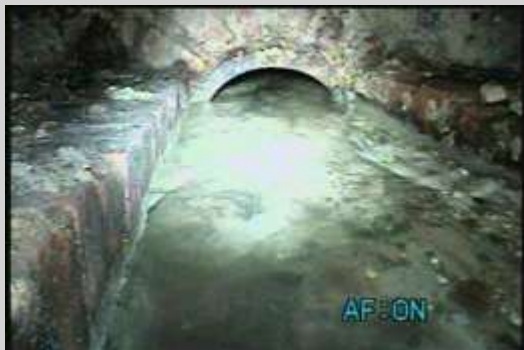
12 O'Clock Outflow

8 in. Circular Gravity Sewer
Pipe Out @ 12 O'Clock

Pipe Material: **Clay** ☐ Pipe Lined

Invert Depth: **12.10** (ft.) Flow Characteristics: **Slow**

Deposits: ☒ None ☐ Mud ☐ Sludge ☐ Debris ☐ Grease

Infiltration: **None** Pipe Seal Cond: **Unknown**

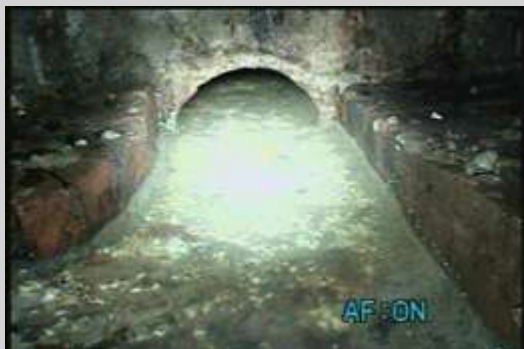
3 O'Clock Inflow

10 in. Circular Gravity Sewer
Pipe In @ 3 O'Clock

Pipe Material: **Clay** ☐ Pipe Lined

Invert Depth: **10.80** (ft.) Flow Characteristics: **Slow**

Deposits: ☒ None ☐ Mud ☐ Sludge ☐ Debris ☐ Grease

Infiltration: **None** Pipe Seal Cond: **Unknown**

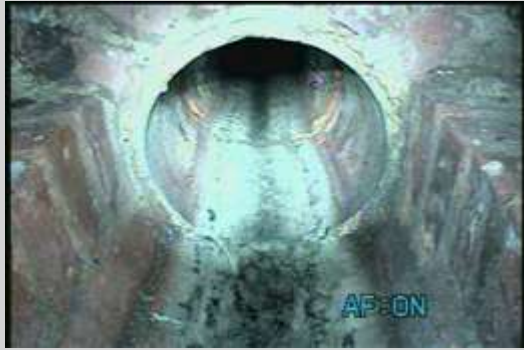
6 O'Clock Inflow

8 in. Circular Gravity Sewer

Pipe In @ 6 O'Clock

Pipe Material: **Clay** ☐ Pipe Lined

Invert Depth: **10.75** (ft.) Flow Characteristics: **Slow**

Deposits: ☒ None ☐ Mud ☐ Sludge ☐ Debris ☐ Grease

Infiltration: **None** Pipe Seal Cond: **Unknown**
